# **Final Report: Results of the 2007 Targeted Investigation at Hilton, Kansas**

by  
Applied Geosciences and Environmental Management Section  
Environmental Science Division, Argonne National Laboratory

February 2008

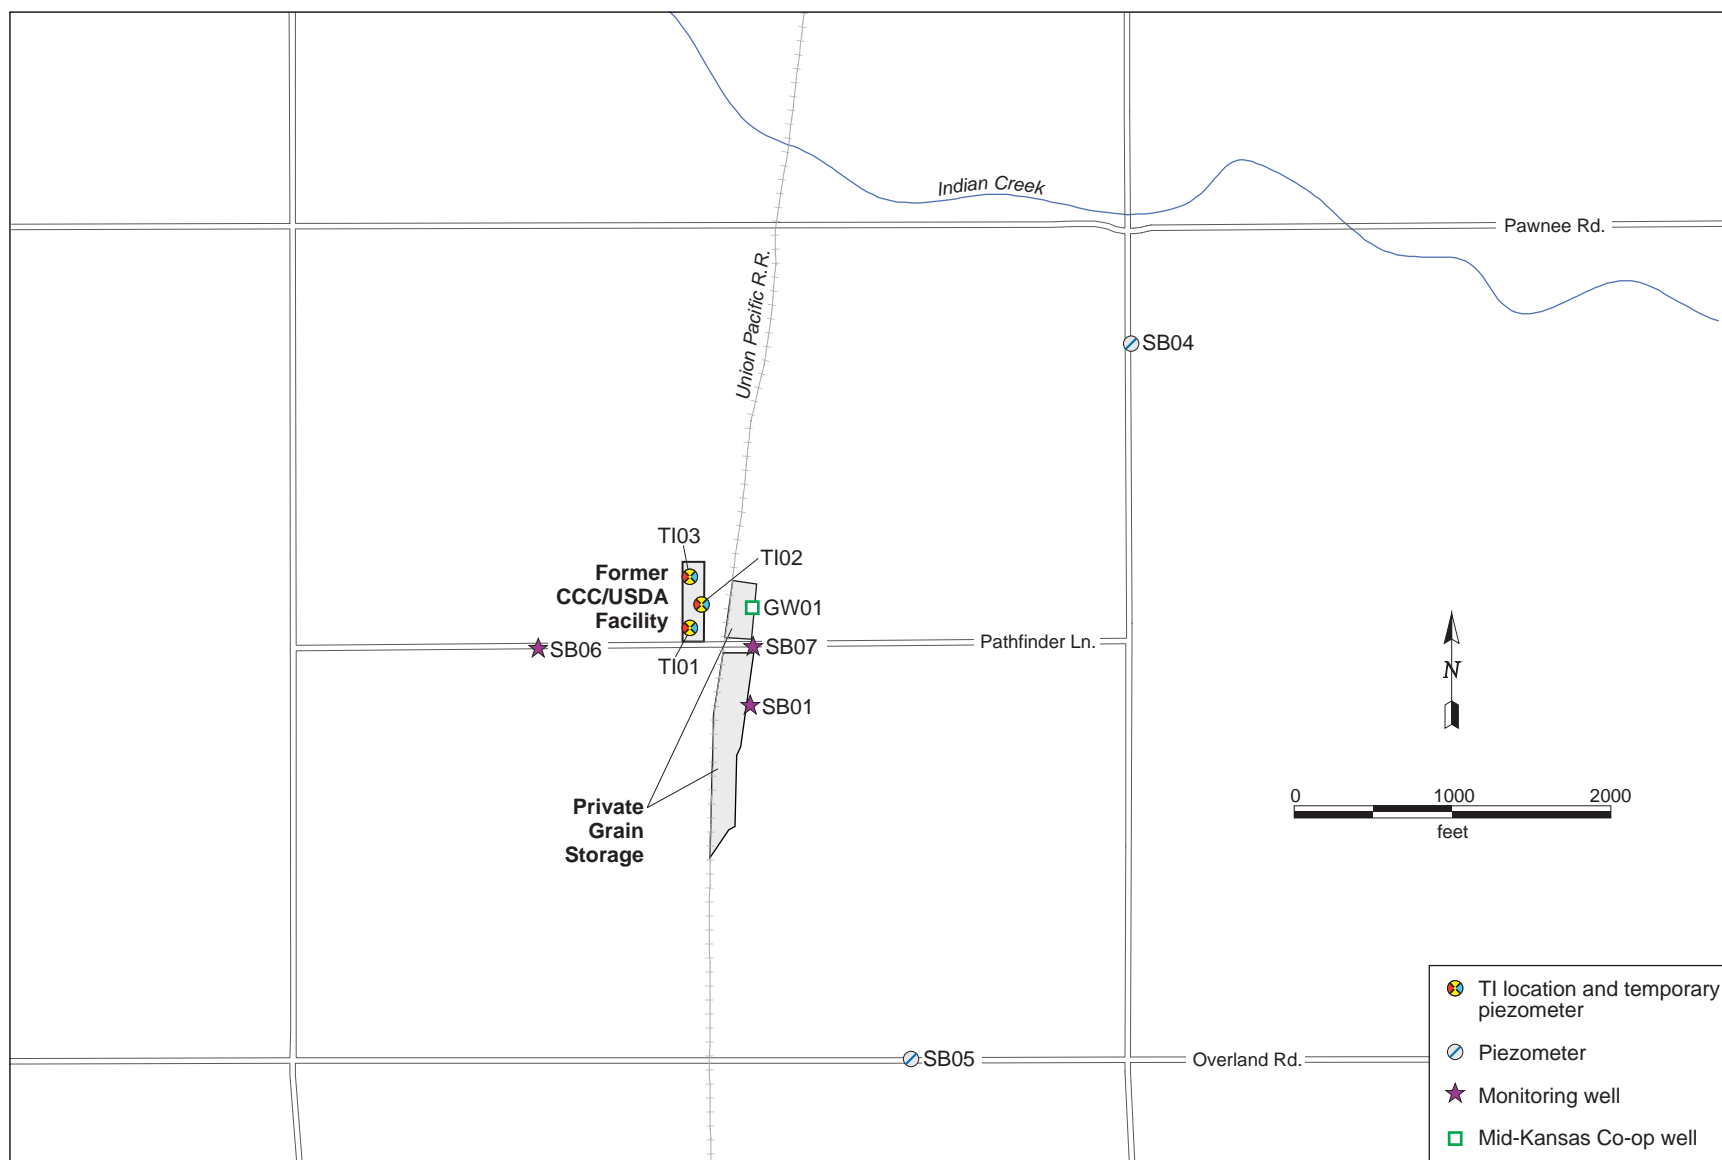
FIGURE 2.1 Locations of field activities in the 2007 targeted investigation at Hilton.

Groundwater samples were also collected from existing monitoring points SB01, SB04, SB06, and SB07 and from Mid-Kansas Co-op well GW01 (Figure 2.1). Previously installed piezometer SB05 was found to have been damaged. The concrete surface housing was detached from the well, and the well casing could not be located. Consequently, no groundwater sample was collected at SB05.

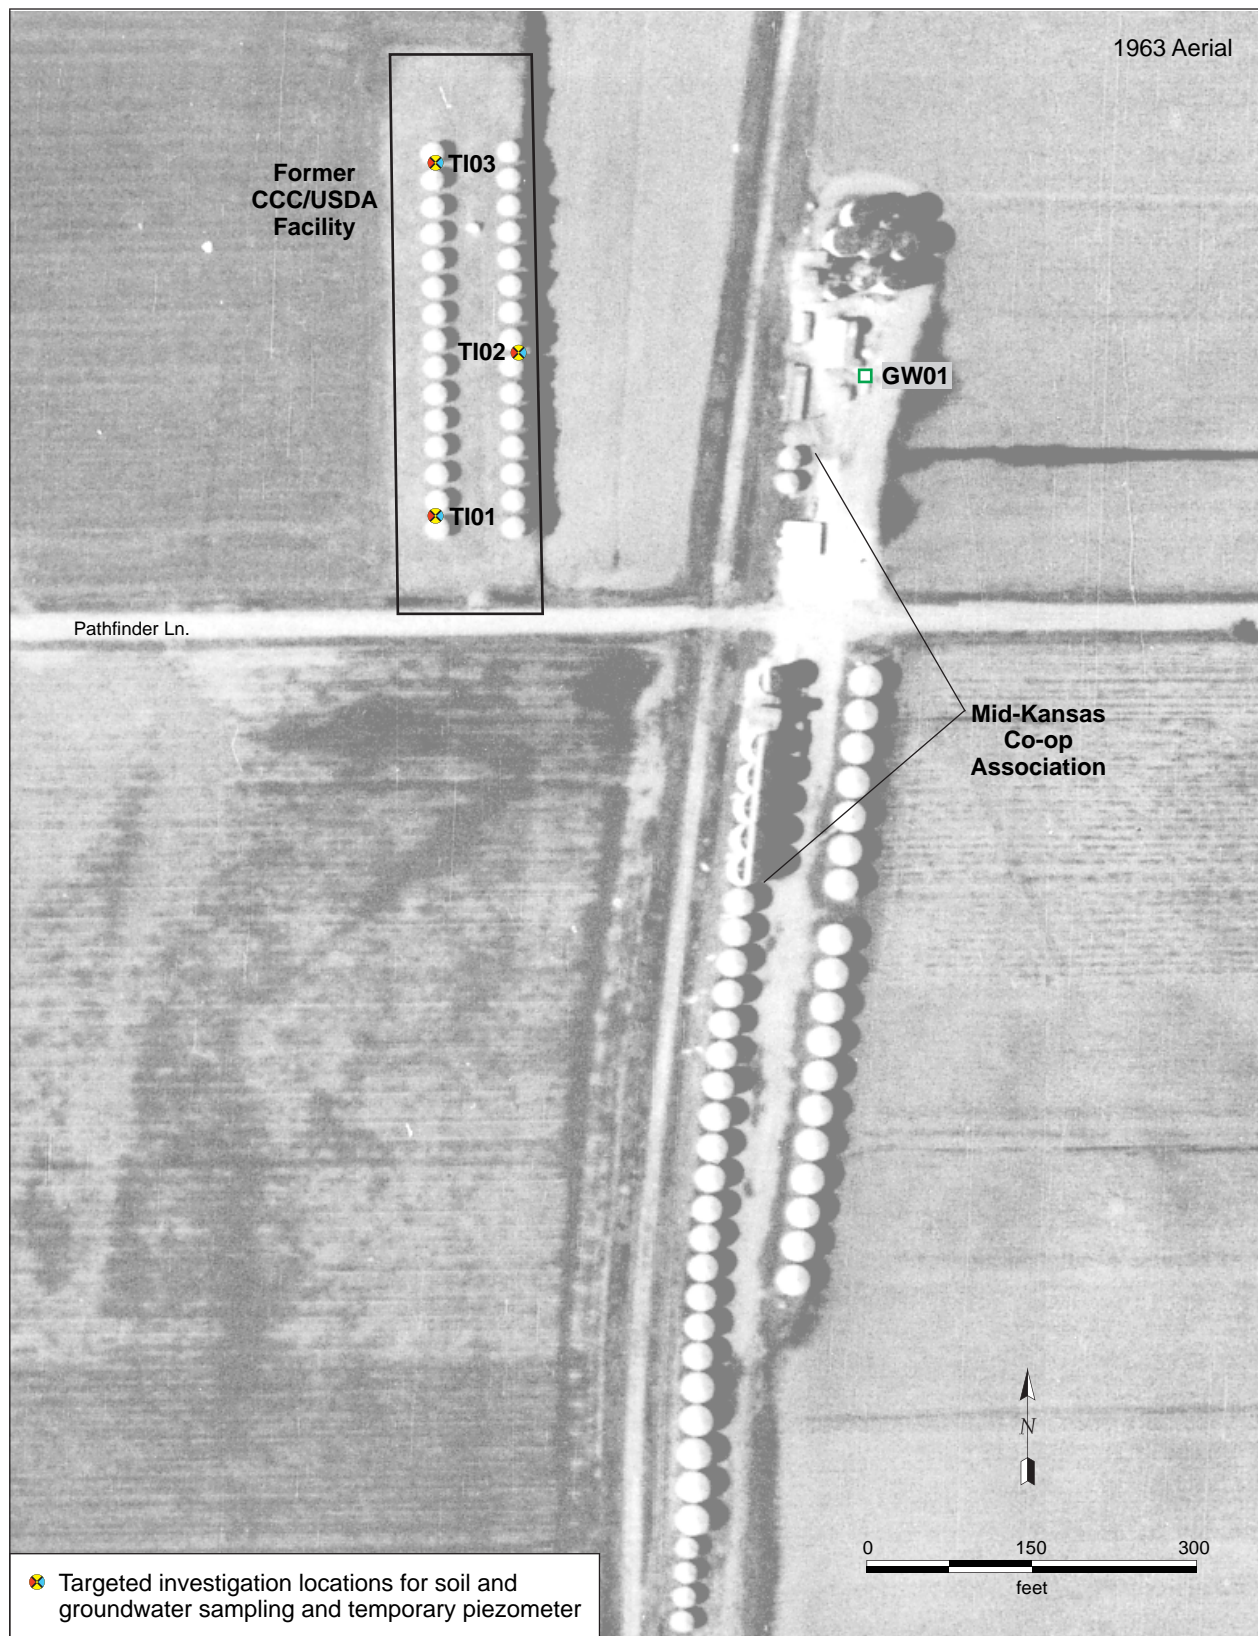
FIGURE 2.2 Sampling locations on the former CCC/USDA property in the 2007 targeted investigation at Hilton. Source of photograph: ASCS (1963).
